# Town of Wasaga Beach, Constance Boulevard Drainage Improvements Schedule 'C' Municipal Class Environmental Assessment

Addendum Report

**TOWN OF WASAGA BEACH, CONSTANCE  
BOULEVARD DRAINAGE IMPROVEMENTS  
SCHEDULE 'C' MUNICIPAL CLASS  
ENVIRONMENTAL ASSESSMENT  
ADDENDUM REPORT**

PROJECT NO. 221057

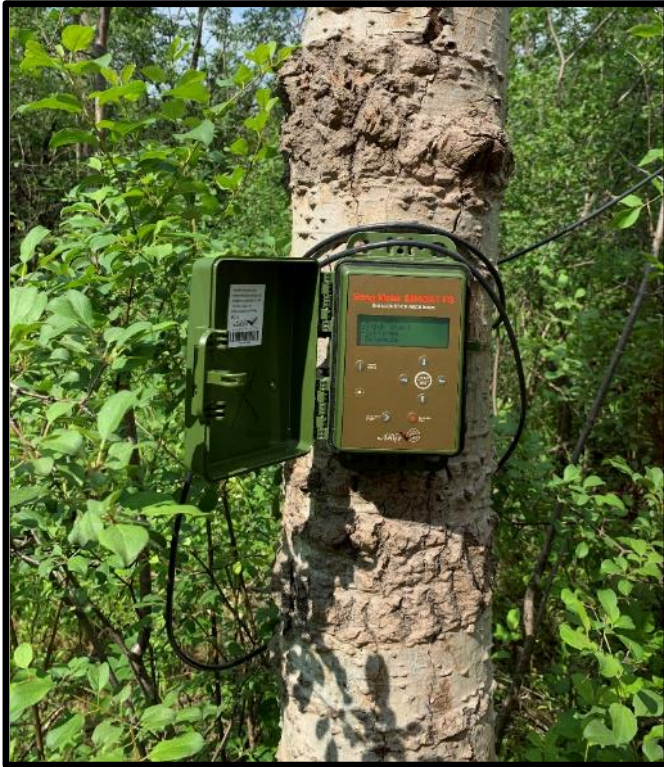
Photo 15: A Song Meter SM4s full spectrum Acoustic Bat Detector mounted on a Poplar tree at Bat Survey Monitoring Site 3.

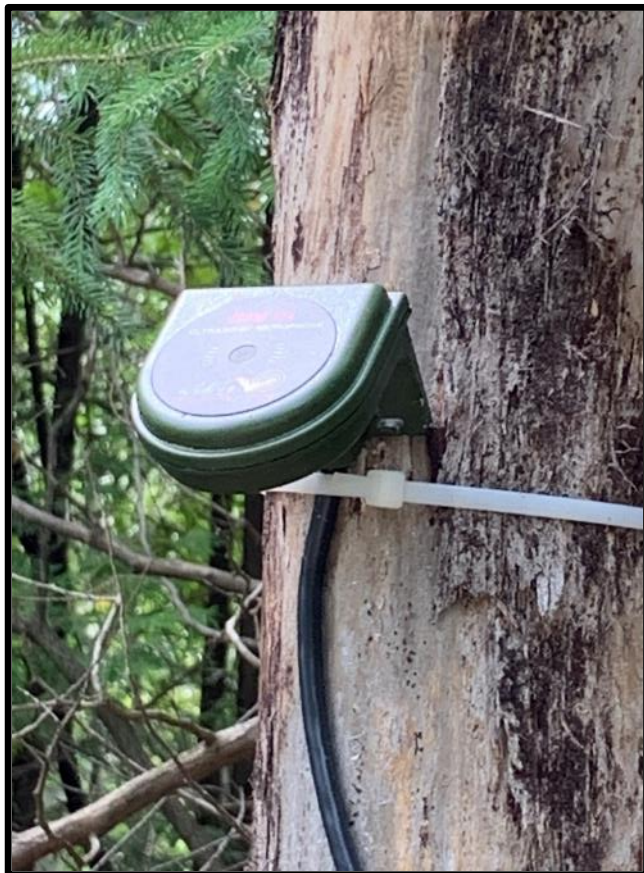
Photo 16: SMM-U2 ultrasonic microphone was connected to the SM4 Detector. The remote microphone provided a substantially greater recording envelope than the microphones built into the detector.

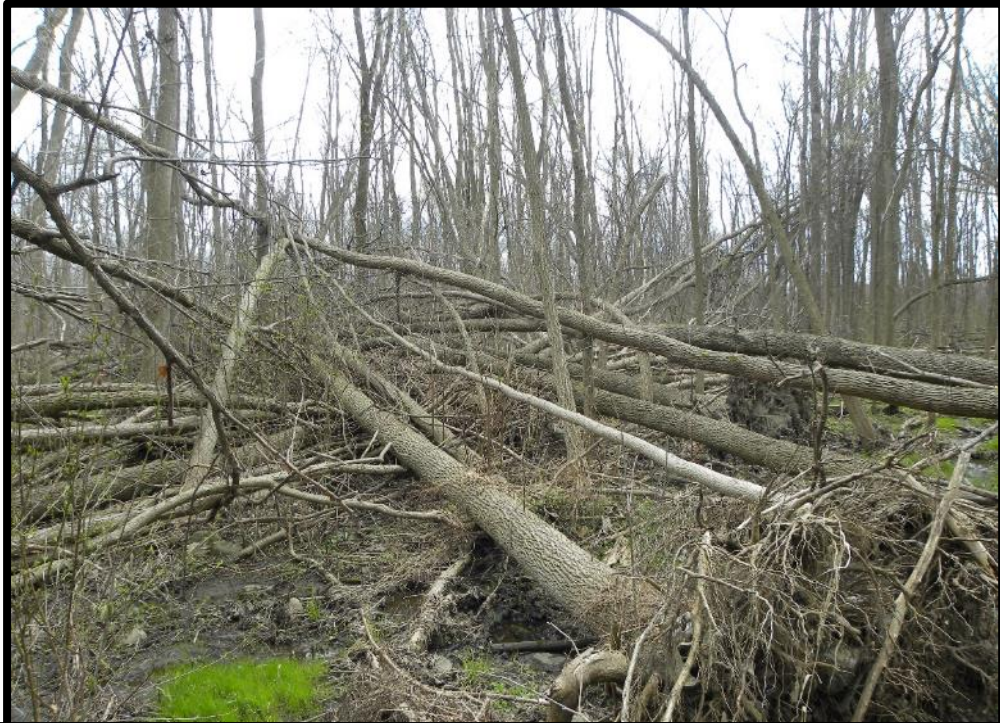
Photo 23: (above) Ash trees killed by the Emerald Ash Borer litter the ground damming and diverting the seasonal flow of water in the wetland causing the ephemeral pooling and ponding to constantly shift location. Photo 24: (below) The high-water table causes very shallow root systems to develop, making mature trees susceptible to blow down. The fallen timber and the root mass also damn and/or divert surface water flow.
